EXCELSIOR SPRINGS HISTORIC RESOURCES

Resource No. 12

Property name, historic The Francis Hotel;
Excelsior Institute; St. Joe Hotel

2. Address/location
105 E. Broadway
Excelsior Springs, MO

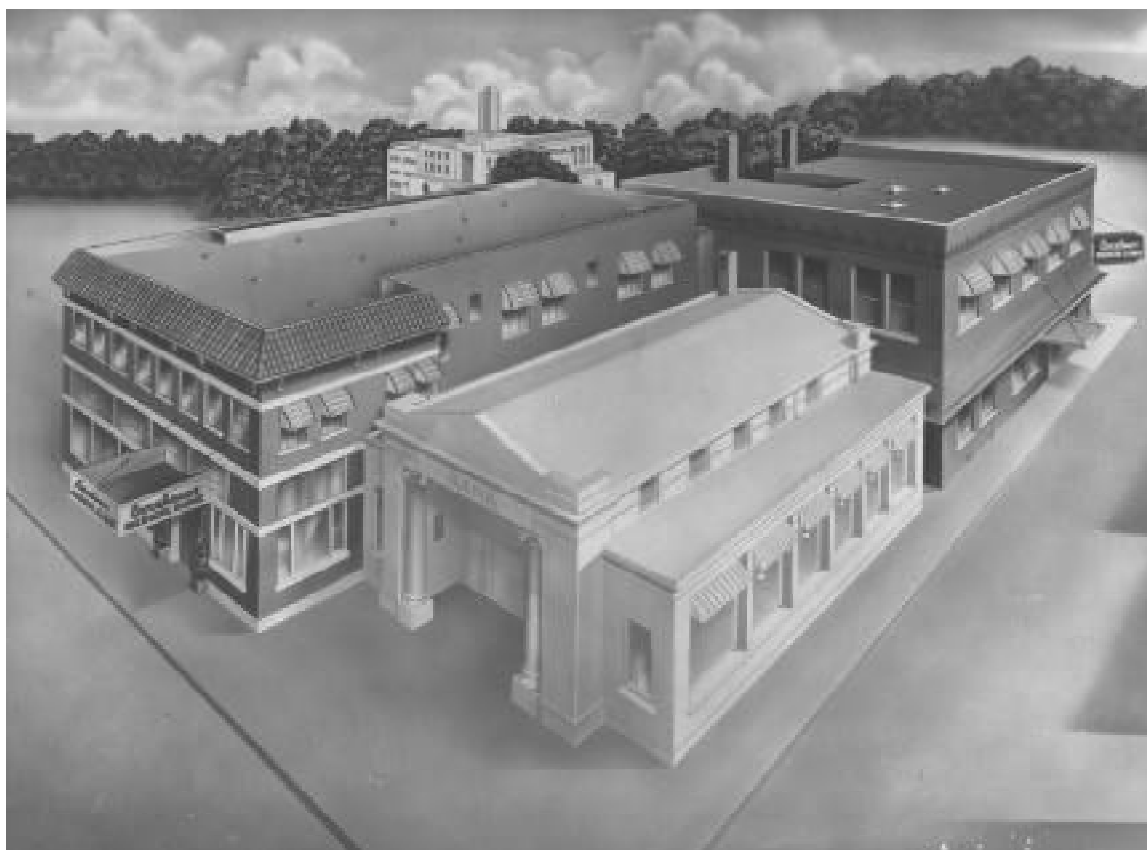
The former Francis Hotel is composed of two structures -- both are two part commercial blocks constructed of brick. 105 E. Broadway is a rectangular structure with a red tile mansard roof. The overhanging boxed eaves are supported by wood knee braces. A stone course separates the 1st floor from the 2nd, and another serves as a continuous lintel above the 2nd story windows. The 2nd story windows are 1/1 and have simple stone sills. On the 1st floor, the entry is recessed. The wood frame windows appear to be original, and have a single, large fixed pane flanked by smaller 1/1 sidelights. The transoms above, however, have been closed. The windows have simple stone sills. The Bank Museum to the west is set slightly back from the sidewalk, leaving a small portion of the west elevation of the Francis exposed. There are windows here on both the 1st and 2nd stories, similar to those on the front (north) elevation.

the west facade has been recently refaced with brick. There are two recessed entries on this elevation, and two signs remain from the Francis Hotel. A mansard roof encircles the west, south and east side between the 1st and 2nd stories. The 1st story of the south facade has been covered with stucco, as has the east elevation. The upper story windows are 1/1 and have simple stone sills. There are rectangular designs in the decorative brick corbeling at the roof cornice line. There is a dead-end alley on the north between the Bank Museum and this portion of the Francis, as well as a one-story connecting hall which leads to the building on E. Broadway. The two buildings are not connected on the 2nd story however, except by a balcony porch with iron railings on the east side facing the Hall of Waters. This arrangement gives windows and light to several rooms on the 2nd story.
